CASE STUDY: Tru-Trac[®] Conveyor Belt Tracking System

Product:	Tru-Trac [®] Conveyor Belt Tracking System
Product category:	Conveyor Belt Tracking
Location:	Power Station, Yallourn, Victoria
Conveyed material:	Brown Coal
Conveyor belt width:	1200 mm to 1400 mm
Conveyor belt speed:	4.5 to 5.0 metres per second
Rate:	2400 tonnes per hour
Installation date:	4 years ago, 2010

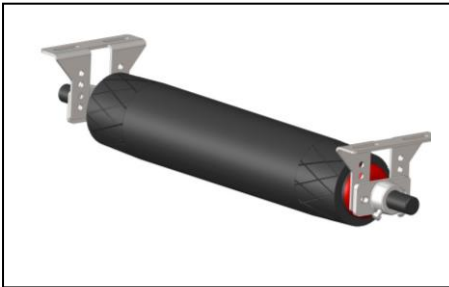
Above: Image of the Tru-Trac® Conveyor Belt Tracking System - the range covers self-aligning idlers for tracking both the return and load-carrying sides on slow moving, reversible, high-speed and high-load belts up to 2500mm.

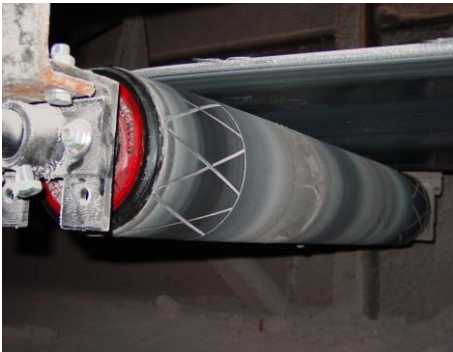
Below: Tru-Trac® Conveyor Belt Tracking System installed.

"I had previously used Tru-Trac® idlers before and decided to trial one on our worst conveyor. I removed the inverted vee and then installed the Tru-Trac® in the same spot which was upside down to the normal fitting method.

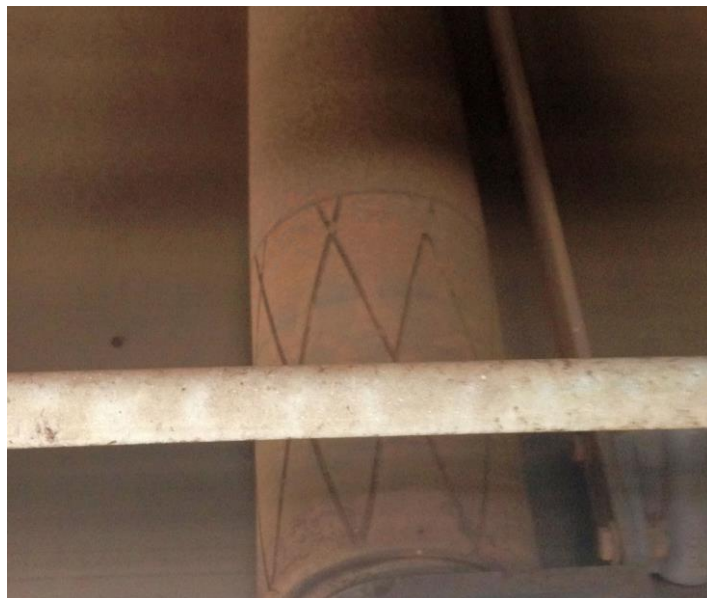
Right: Tru-Trac® customised installation at the Power Station.
