CASE STUDY: K-Impact Belt Support System

Product:	K-Impact Belt Support System
Product category:	Belt Support
Location:	Geraldton, Western Australia
Conveyed materials:	Iron Ore
Installation date:	February 2014

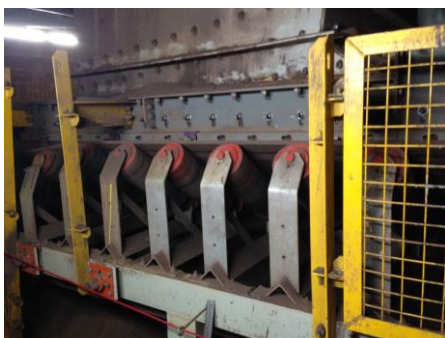
Above: Aerial photograph of our customer's Geraldton facility.
Below: Previously used conveyor idlers.

At the key loading zone area, the original trough support frames were beginning to fatigue, in part accelerated due to the increased output, but also the trough frames were not suitable for the types of heavy loads that our customer manages.

The existing trough supports required an increasing amount of maintenance and they were creating significant levels of spillage that had to be cleared manually on a daily basis.

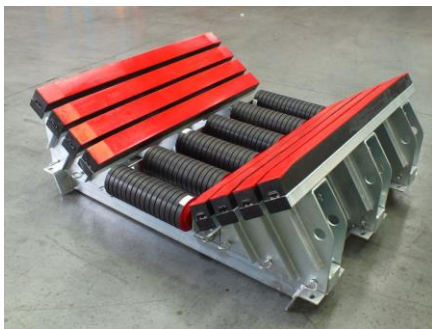
Above: K-Impact Belt support System, Model XHDF – Combination Roller / Impact Bar.

After research and then consultation with our Sales Engineer, our customer decided to install the K-Impact Belt Support System to meet the needs of the Facility's heavy duty and increased material handling projections. They used this opportunity to request some modifications.

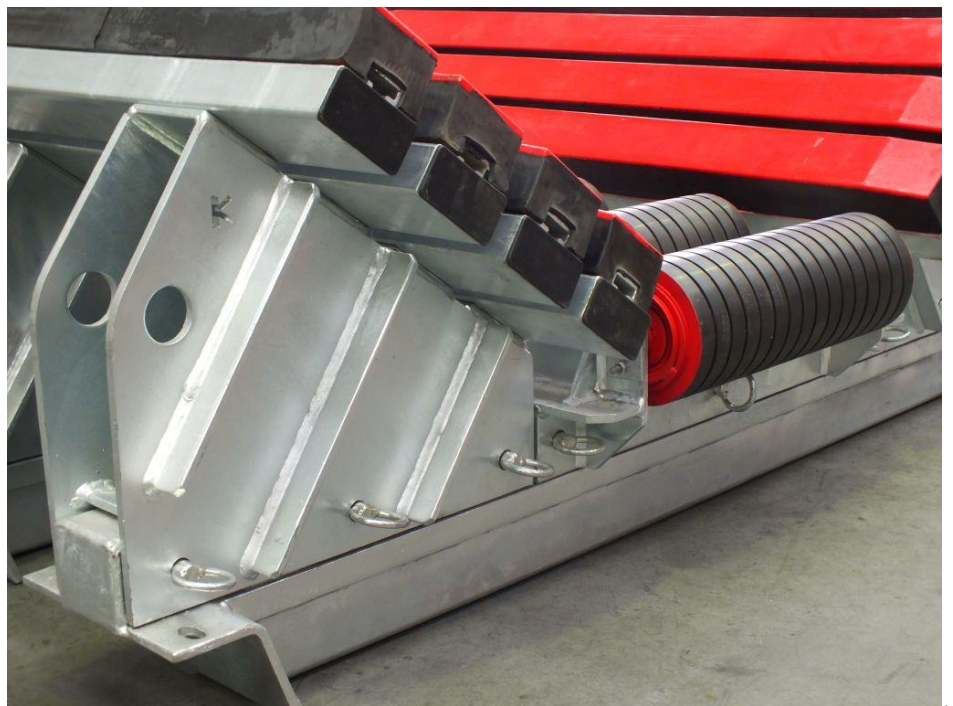
Right: Close-up of quick release pins and side support hole modifications.

The customer's first modification idea was the creation of quick release pins for ease of installation and ongoing maintenance. The second modification was a joint idea between customer and Kinder Australia. This was the addition of holes in the side supports to enable a chain or sling to help retract the side for ongoing maintenance.
