## CASE STUDY: K-Sure® Belt Support and K-Ultra Dual Seal

<b>Kinder Australia Product:</b>	<b><u>K-Sure® Belt Support and K-Ultra Dual Seal</u></b>
<b>Product Category:</b>	Belt Support and Conveyor Skirting and Sealing
<b>Location:</b>	Auckland, New Zealand
<b>Conveyed Materials:</b>	Lime
<b>Conveyed Belt Width/Speed:</b>	800mm / 1 metre per sec
<b>Rate / tonnes per hour</b>	100
<b>Installation Date:</b>	May 2017

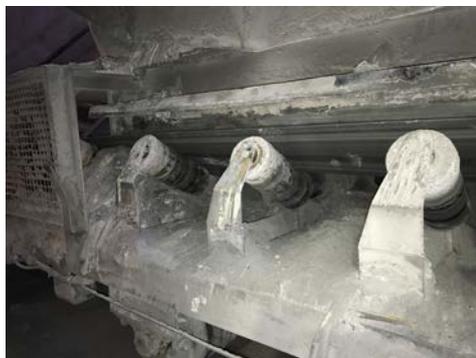
**RIGHT**  
Image  
BEFORE Installation

Site inspections at the steel plant exposed major inefficiencies in material flow, as well as excessive material spillage and dust emissions between existing skirting and conveyor belt, due to the distance between frames. These inefficiencies resulted in frequent shutdowns and spiralling clean-up costs necessitating recruitment of an external cleaning contractor to manage material spillage minimising environmental and potential safety hazards.

Premature belt wear and tracking issues were also identified, with material becoming trapped under the conveyor belt and accumulating on the conveyor structure.

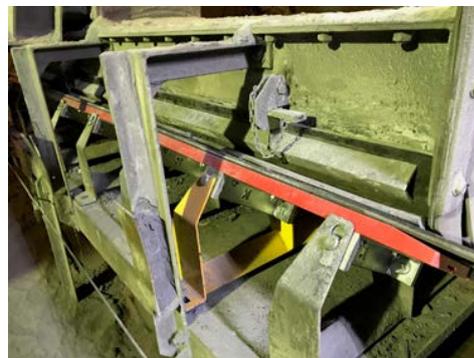
**LEFT**  
Image  
AFTER Installation

After two previous faultless installations of **K-Sure® Belt Support System** and **K-Ultra Dual Seal** at the site, it was agreed this combined solution be rolled out within the steel plant's impact zone, under the chute. Two extra **K-Sure® Belt Support** frames were introduced to reduce gap support to 300mm solely for rail support, including a lead on frame.

The existing conveyor belt was removed and frames packed carefully to ensure 100% linear surface. Prior working knowledge of the plants intricacies meant installation was conducted seamlessly & efficiently, with minimal time and labour, including drilling of extra frames.

The steel plant can confidently confirm the recommended conveyor belt support and skirting solution has exceeded its performance expectations, with virtually no material spillage plus the facilitation of a continuous and uninterrupted flow of conveyed materials throughout the plant. Other positive outcomes include significant clean-up costs savings due to reduction in material spillage and dust containment.
