## CASE STUDY: K-Sure® Belt Support & K-Containment Seal

Kinder Australia Products:	K-Sure® Belt Support System & K-Containment Seal
Product Category:	Conveyor Belt Support
Site Location:	Ohau Quarry, Levin, New Zealand
Conveyed Material:	Face Rock
Location on Conveyor:	Conveyor Transfer Point
Installation Date:	July 2014 – still in operation

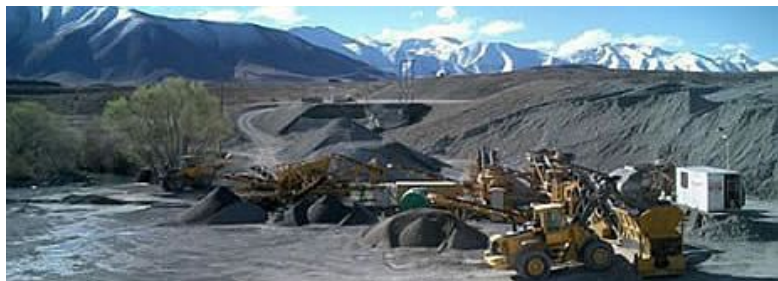
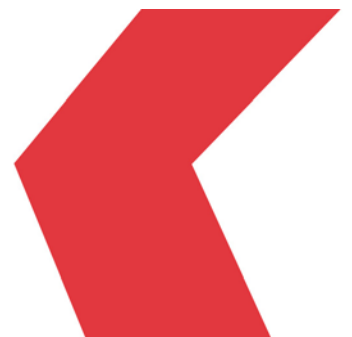
Ohau Quarry had issues with face rock getting past the skirt, resulting in significant damage to the belt. Typically the conveyor belt would be changed out every 3 months due to the re-occurrence of the **impact damage**, caused by the large, sharp face rock lumps striking the belt. Entrapment damage was also being experienced, created by friction between the rock material on the belt, the belt surface and the bottom of the skirt board when the **belt sags**.

First a belt support system was installed underneath the conveyor belt at the impact zone. The **K-Sure® Belt Support** is designed to support the belt and provide a consistent and stable support for the troughed conveyor belt profile. It was retrofitted, utilising the existing idler frames so no pre-engineering was required. It operates by replacing the existing wing rollers with strong, highly durable low friction polymer slider support rails. It was simple install and will require minimal ongoing maintenance and no adjustments.

Once the belt was supported adequately, conveyor skirting can function along a flat, sag-free belt line. The **K-Containment Seal** is a high performance skirt system that offers exceptional resistance to wear. The slotted system arrangement extends its service life by allowing for further ongoing adjustment after initial installation.
