CASE STUDY: K-Sure®, K-Impact Belt Support, K-Ultra Dual

Kinder Australia Product:	K-Sure®, K-Impact Belt Support, K-Ultra Dual and Return Vee Plough
Product Category:	Conveyor Skirting & Sealing
Location:	Victoria
Conveyed Materials:	Hornfels Hard Rock
Installation Date:	September 2016

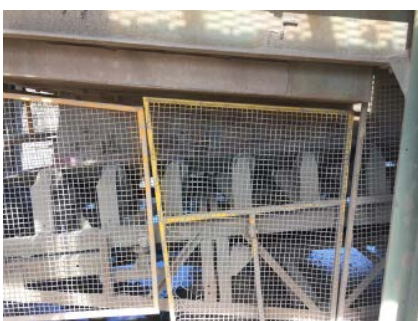
The transfer point under the tertiary crusher was a source of excessive spillage and dust emission. After many years of service and increased load due to plant productivity increases the belt was at capacity. This resulted in the area flooding and not containing the crushed material.

Material turbulence generating huge amount of dust in the tertiary crushing process, was ultimately escaping and causing constant emissions from conveyor belt skirting system. Dust had been reported to cause issues and blockages of the spray nozzles and the site had attempted wetting the product, however this led to binding the screens further along in the next process.

With the vertical impact drop height from the cone crusher being 2.5m and a lump size of minus 60mm provided evidence that the material was pooling, due to the material not moving in the direction of the conveyor belt. A combination of conveyor belt sag and inconsistent conveyor idler profile resulted in an ineffective skirting system, therefore resulting in the dust emissions and spillage.

ABOVE
Image of Transfer point *BEFORE*
Conveyor Upgrade

After an in-depth report was submitted, this Quarry elected to overhaul the conveyor by fabricating a new tail section and followed recommendations to install: a **K-Impact Belt Support System, a K-Sure® Belt Support System, K-Ultra Dual Seal Skirting System** and a Return Vee Plough.

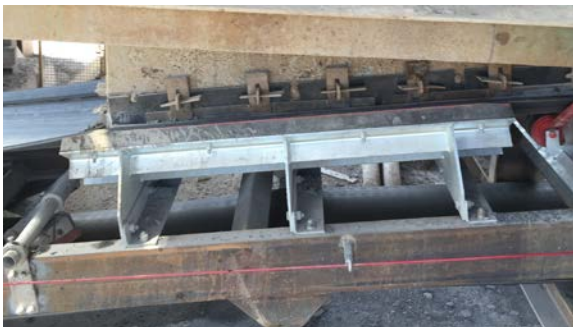
All 3 systems were installed during the week of the 19/09/2016. During the first follow-up meeting between the Kinder Australia Pty Ltd Operations Management and the Maintenance Team, on the 20/10/2016, it was recorded that the project upgrade was perceived as a very positive success, with minimal reported dust from the skirting system. The only dust reported was observed to be appearing from another source near the crusher discharge.

A second follow up meeting with the Maintenance Team, was conducted on the 06/01/2017 and it was advised that the upgrade was continuing to meet the site's expectations. Some additional positive observations, in that the site had experienced a reduction in downtime in the area, as the skirting hadn't required any adjustment since the installation, usually conducted monthly.

This was understood to be a combined result of the conveyor belt sag not allowing material to get up under the skirting, causing a pinch point and the polyurethane skirting tip, being an abrasion resistant material.

ABOVE
Image of Transfer point AFTER
Conveyor Upgrade
