CASE STUDY: K-Sure[®] Belt Support and K-Ultra Dual[®] Seal

Kinder Australia Product:	<u>K-Sure[®] Belt Support and K-Ultra Dual[®] Seal</u>
Product Category:	Belt Support and Conveyor Skirting and Sealing
Location:	Auckland, New Zealand
Conveyed Materials:	Lime
Conveyed Belt Width/Speed:	800mm / 1 metre per sec
Rate / tonnes per hour	100
Installation Date:	May 2017

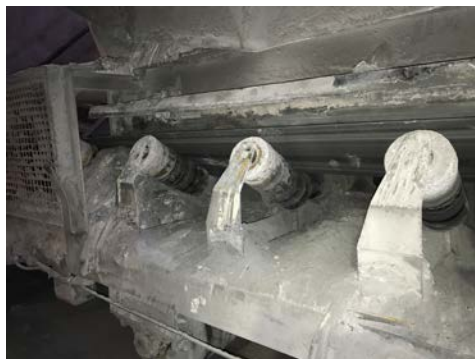
RIGHT
Image
BEFORE Installation

Site inspections at the steel plant exposed major inefficiencies in material flow, as well as excessive material spillage and dust emissions between existing skirting and conveyor belt, due to the distance between frames. These inefficiencies resulted in frequent shutdowns and spiralling clean-up costs necessitating recruitment of an external cleaning contractor to manage material spillage minimising environmental and potential safety hazards.

Premature belt wear and tracking issues were also identified, with material becoming trapped under the conveyor belt and accumulating on the conveyor structure.

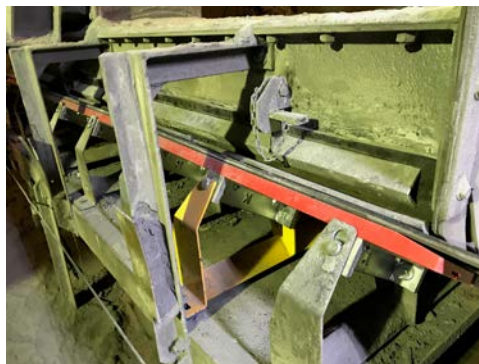
LEFT
Image
AFTER Installation

The steel plant can confidently confirm the recommended conveyor belt support and skirting solution has exceeded its performance expectations, with virtually no material spillage plus the facilitation of a continuous and uninterrupted flow of conveyed materials throughout the plant. Other positive outcomes include significant clean-up costs savings due to reduction in material spillage and dust containment.

After two previous faultless installations of **K-Sure[®] Belt Support System** and **K-Ultra Dual[®] Seal** at the site, it was agreed this combined solution be rolled out within the steel plant's impact zone, under the chute. Two extra **K-Sure[®] Belt Support** frames were introduced to reduce gap support to 300mm solely for rail support, including a lead on frame.

The existing conveyor belt was removed and frames packed carefully to ensure 100% linear surface. Prior working knowledge of the plants intricacies meant installation was conducted seamlessly & efficiently, with minimal time and labour, including drilling of extra frames.
