CASE STUDY: K-Sure[®], K-Impact Belt Support, K-Ultra Dual[®]

| Kinder Australia Product: | K-Sure[®], K-Impact Belt Support, K-Ultra Dual[®] and Return Vee Plough |
| Product Category: | Conveyor Skirting & Sealing |

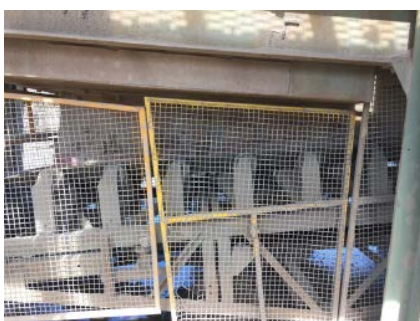
The transfer point under the tertiary crusher was a source of excessive spillage and dust emission. After many years of service and increased load due to plant productivity increases the belt was at capacity. This resulted in the area flooding and not containing the crushed material.

Material turbulence generating huge amount of dust in the tertiary crushing process, was ultimately escaping and causing constant emissions from conveyor belt skirting system. Dust had been reported to cause issues and blockages of the spray nozzles and the site had attempted wetting the product, however this led to binding the screens further along in the next process.

With the vertical impact drop height from the cone crusher being 2.5m and a lump size of minus 60mm provided evidence that the material was pooling, due to the material not moving in the direction of the conveyor belt. A combination of conveyor belt sag and inconsistent conveyor idler profile resulted in an ineffective skirting system, therefore resulting in the dust emissions and spillage.

ABOVE
Image of Transfer point *BEFORE*
Conveyor Upgrade

After an in-depth report was submitted, this Quarry elected to overhaul the conveyor by fabricating a new tail section and followed recommendations to install: a **K-Impact Belt Support System**, a **K-Sure[®] Belt Support System**, **K-Ultra Dual[®] Seal Skirting System** and a Return Vee Plough.

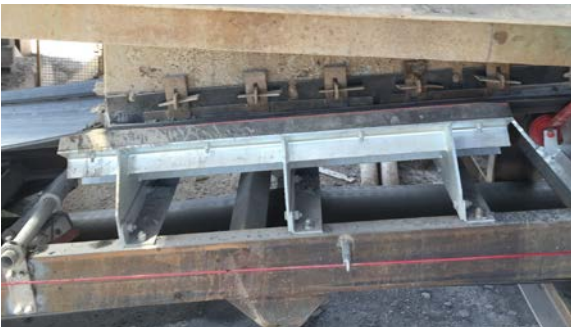
All 3 systems were installed during the week of the 19/09/2016. During the first follow-up meeting between the Kinder Australia Pty Ltd Operations Management and the Maintenance Team, on the 20/10/2016, it was recorded that the project upgrade was perceived as a very positive success, with minimal reported dust from the skirting system. The only dust reported was observed to be appearing from another source near the crusher discharge.

A second follow up meeting with the Maintenance Team, was conducted on the 06/01/2017 and it was advised that the upgrade was continuing to meet the site's expectations. Some additional positive observations, in that the site had experienced a reduction in downtime in the area, as the skirting hadn't required any adjustment since the installation, usually conducted monthly.

This was understood to be a combined result of the conveyor belt sag not allowing material to get up under the skirting, causing a pinch point and the polyurethane skirting tip, being an abrasion resistant material.

ABOVE
Image of Transfer point AFTER
Conveyor Upgrade
