CASE STUDY: K-Sure[®] Belt Support System

Kinder Australia product:	K-Sure Belt Support
Kinder Australia product category:	Conveyor Belt Support
Location:	Ormeau, Queensland
Conveyed materials:	Crushed Greywacke
Conveyor belt width:	750mm
Installation date:	October 2015

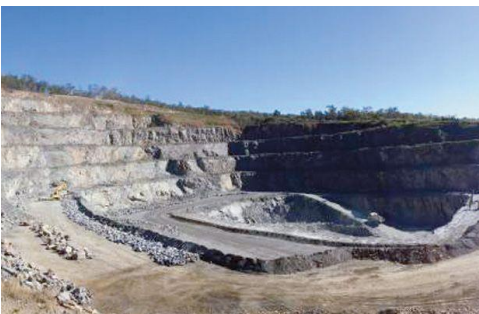
Above: customer site
Below: 3D drawing of K-Sure Belt Support

1. The weight pressure of transferred material load was causing the **conveyor belt to sag in between the supporting rollers**. Belt edge sag allows the material to spill through the gaps that appear between the skirting and the belt, and as well as creating spillage. Smaller rocks have the potential to get caught between the belt and the skirting, causing premature groove lines in the belt's top cover. Tears and blockages will occur if fines are not identified and removed.

2. The impact of the material causes a **dust problem requiring constant deployment of labour resources** to clear up the dust creating a physical manual labour OHS issue as well as an environmental air pollution issue.

A resolution was required to suit a **confined access space** around the chute.

Kinder Australia recommended the installation of the **K-Sure Belt Support to fix the problem of belt sag**. This belt support system is designed to provide even and consistent support under the belt, utilising low friction UHMWPE sliding surface bars instead of rollers. Also, with **no moving parts that would wear in the future**, this solution will remove the need to change rollers in the awkward space.

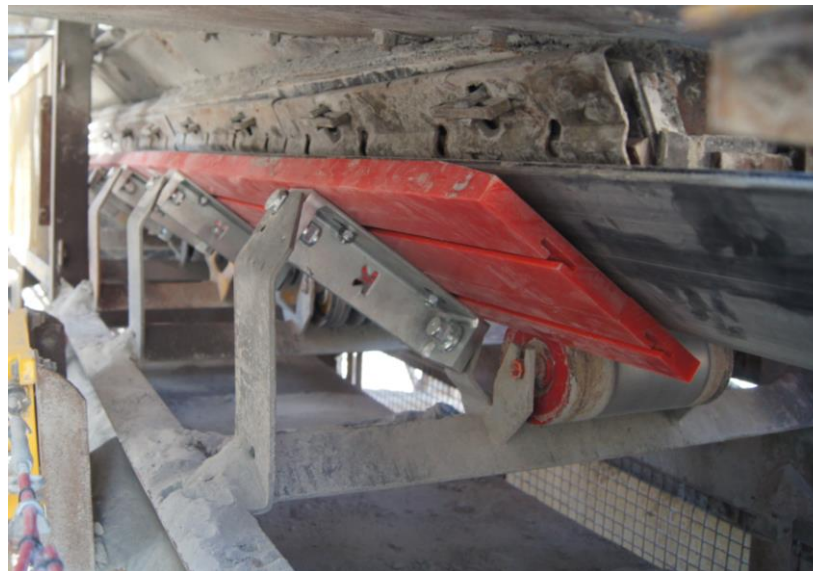
Right: images taken of K-Sure Belt Support after installation.

Kinder Australia then recommended the installation of the double layered **K-Ultra Dual Seal** to trap the dust particles effectively. Mounted using shallow clamps it is ideal for this confined access location. This skirt works by utilising an interior wear resistant layer of polyurethane (longer lasting than rubber skirting), but it also has an outer anti-dust integral moulding that can adapt to belt vibration and **maintain the correct pressure** to effectively seal the belt.
