CASE STUDY: K-Superline®

Product:	K-Superline® Polyurethane Lining Sheet
Product category:	Flow & Anti Wear
Location:	Dandenong, Victoria
Product description:	K- Superline® solid polyurethane sheet, G83 Durometer
Conveyed materials:	20mm, 17mm and 14mm aggregate and manufactured sand
Conveyed belt speed:	Vertical drop of 500mm
Installation date:	September 2014

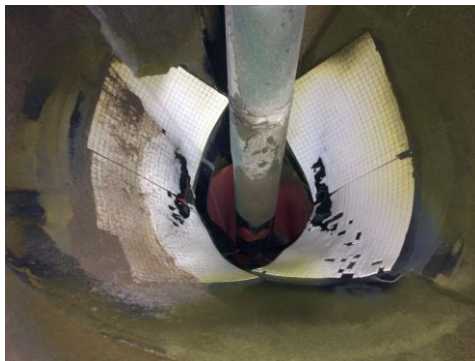
Above: Photo showing the worn ceramic lining trialled inside the wok.
Below: photo of worn rubber lining

At the Dandenong site, Kinder Australia's ceramic wear lining panels were supplied by a different supplier and trialled as a way to conserve the steel walls of the wok structure. However due to the concentrated high volume impact of the abrasive aggregate, the tiles became broken or dislodged.

This failure was also due its adhesive method of installation best suited to flat and level lining requirements. The curved surface of the wok compromised the bond of the ceramic, causing buckling. This very quickly then lead to the individual ceramic modules peeling off the lining backing.

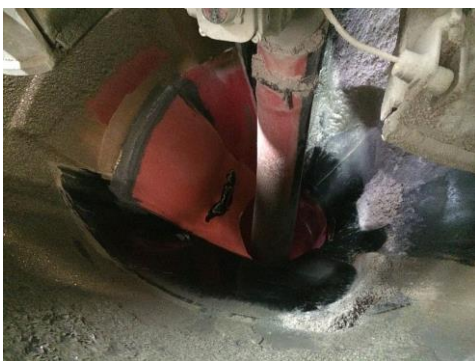
As an interim lining, a high quality rubber lining was then installed by the same supplier, which began to show even higher levels of erosion after a short time in use.

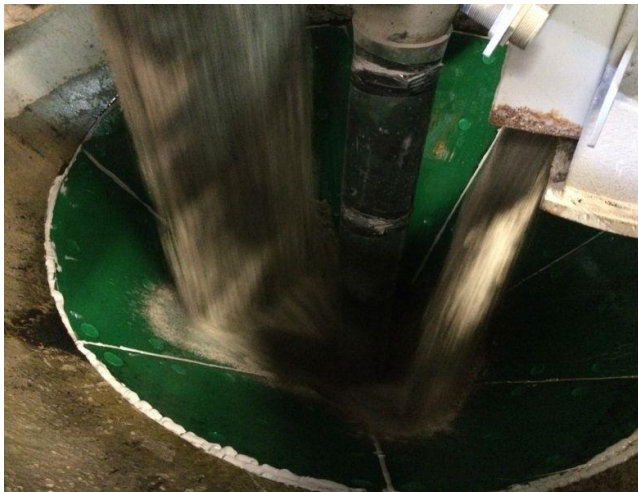
K-Superline® after installation at Dandenong, Sept 2014

Given the curved nature of the wok, 8 panels of K-Superline® were **water-cut to precise measurements** with a pattern of bolts replicated on each sheet.

The **bolt-on design** of K-Superline® has the potential of allowing worn areas to be swapped and manoeuvred with other less worn sheets. In a confined space, this can be done quickly and **without the need for welding equipment**.

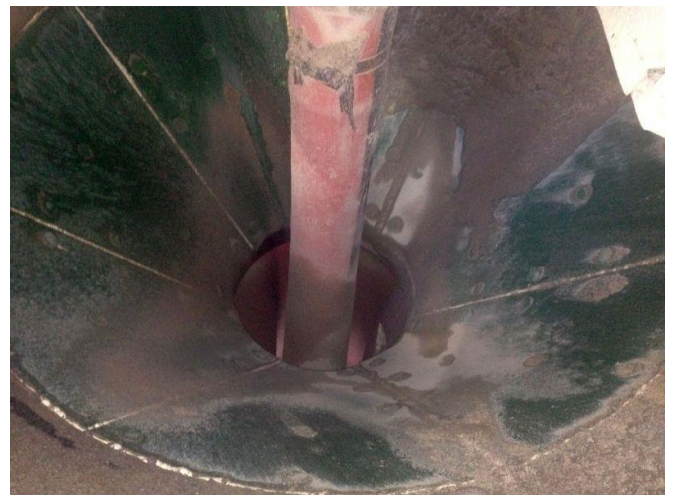
K-Superline® has now been installed at the Dandenong site for 5 months and is showing no signs of wear. **K-Superline® has exceeded our customer's expectations of its durability potential.**

Same K-Superline® in Feb 2015, showing no signs of wear.
