CASE STUDY: K-Snap-Loc® Dust Seal System

Product:	K-Snap-Loc® Dust Seal
Product category:	System® Conveyor Skirting &
Location:	Transfer Port Pirie Wharf, South
Conveyed material:	Australia Zinc and lead
Installation date:	concentrates June 2011

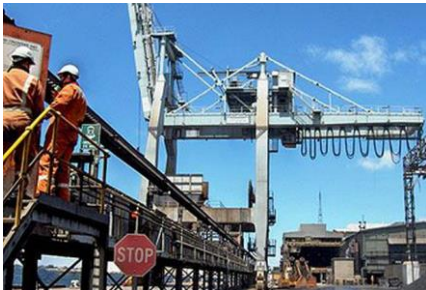
Photo on site of the Port Pirie bulk handling systems.

The area requires a green field approach to all aspects of bulk logistics at their facilities and so the existing clamped rubber skirting was not only causing wear and tear damage to the conveyor belt, but it was also creating a significant amount of bulk materials spillage.

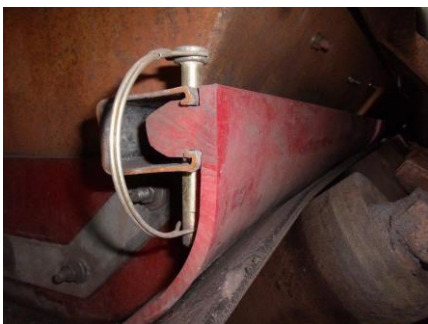
Detail photo of K-Snap-Loc Dust Seal System installed.

The team of sales engineers at Kinder Australia recommended the installation of the engineered polyurethane Ester G96A dust seal system, K-Snap-Loc®.

Also the K-Snap Loc® was surprisingly very simple to install and being lighter than the rubber, it made our job much easier."
